**Preliminary Assessment of a pair of wall paintings in the Nave at  
The Church of Saint Peter & Saint Paul  
Burgh le Marsh  
Lincolnshire**

**Client: St Peter & Paul PCC**

**Author: Paul Croft (Conservator & Research Fellow)**

**September 2016**

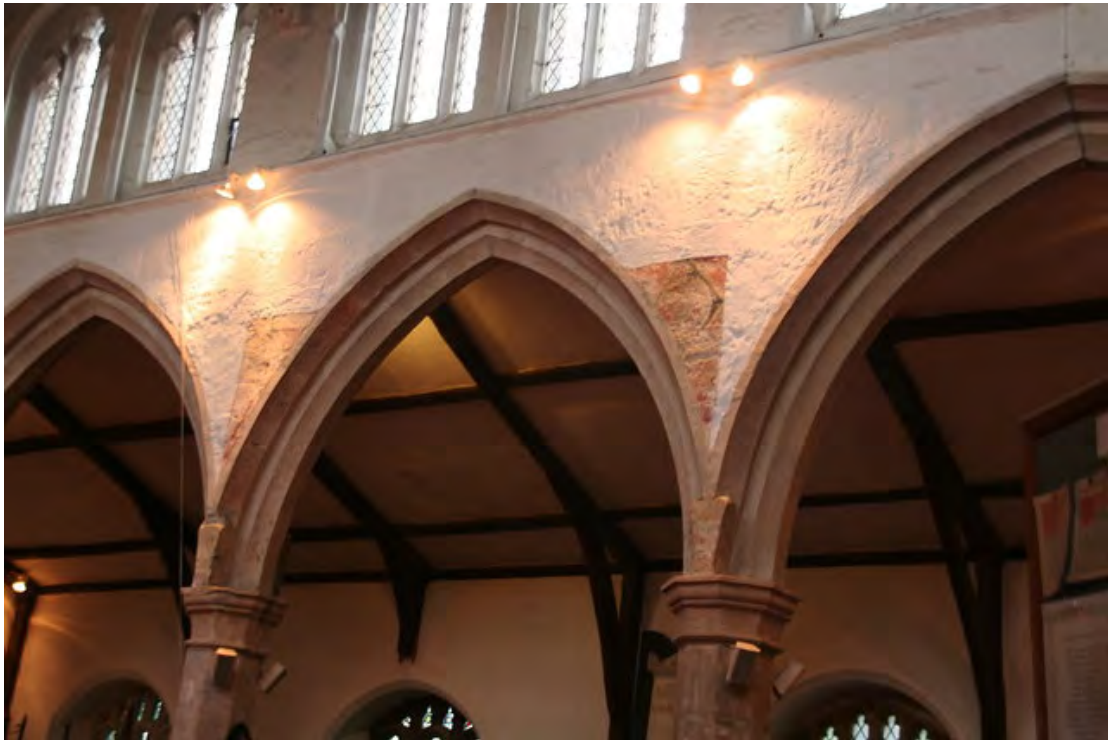
Fig.2: The Wall Paintings

Although both paintings are in poor condition, sufficient detail remains of their design to determine they were painted on a red surrounding background, framed with a lozenge shape defined using a yellow border with a twisted rope(?) design painted onto the border. Both lozenges are divided vertically with black on the right hand side and white on the left hand side of the easternmost, and red on the left hand side of the westernmost. Traces of a central armorial design are visible on both paintings, including what appears to be three lions passant on a red background. The remaining armorial detail is less legible.

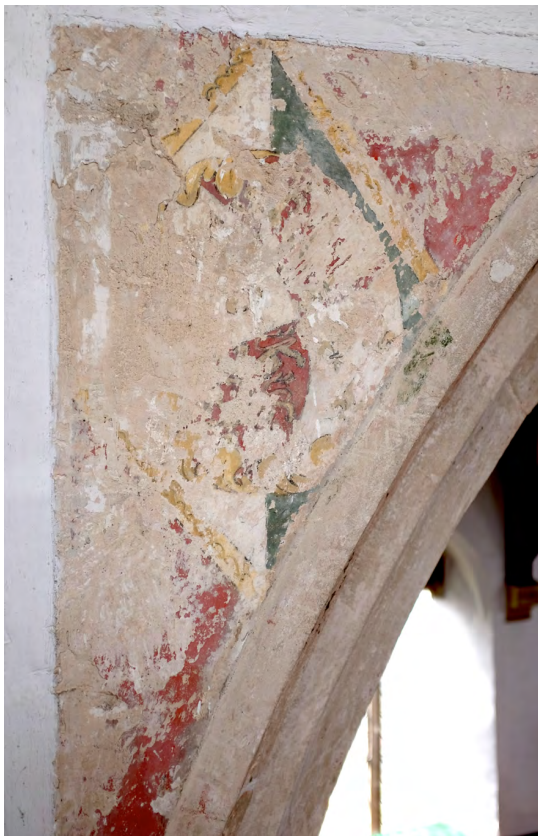
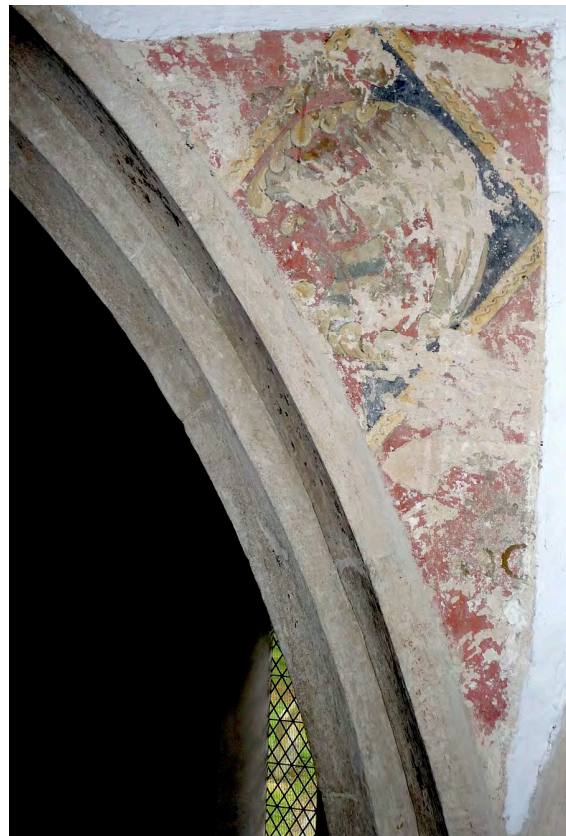
Fig.3: Detailed view (see also appendix)

The “hatchment” design of the wall paintings is clearly visible in fig.3. Both sections are surrounded with later layers of paint or similar coating, which raises the question: “have the two extant paintings been *revealed*, by cleaning back the later layers of paint to expose them, or have they always been visible and left untouched during periods of re-decoration in the church”. This remains unclear at this stage, but a close inspection of the surface on both does appear to reveal areas that may have been scraped back in the past in an attempt to remove the later over-paints to uncover the wall paintings and if so, contributed significantly to their current poor condition.

The wall paintings may extend further beneath the white paint/coatings that surround them - note how the yellow border on the rightmost painting is partially obscured under the later layers of paint (particularly at the top). *This is an area requiring further investigation* by an experienced accredited conservator to assess the risks of undertaking further uncovering work. Such an exercise is likely to involve mechanical and/or chemical techniques that may compromise the integrity of the underlying wall paintings and great care and consideration should be taken before any attempt is made. It may be advisable to leave them as they are, or possibly attempt to peer beneath the surface of the surrounding white paint using a non-invasive technique.

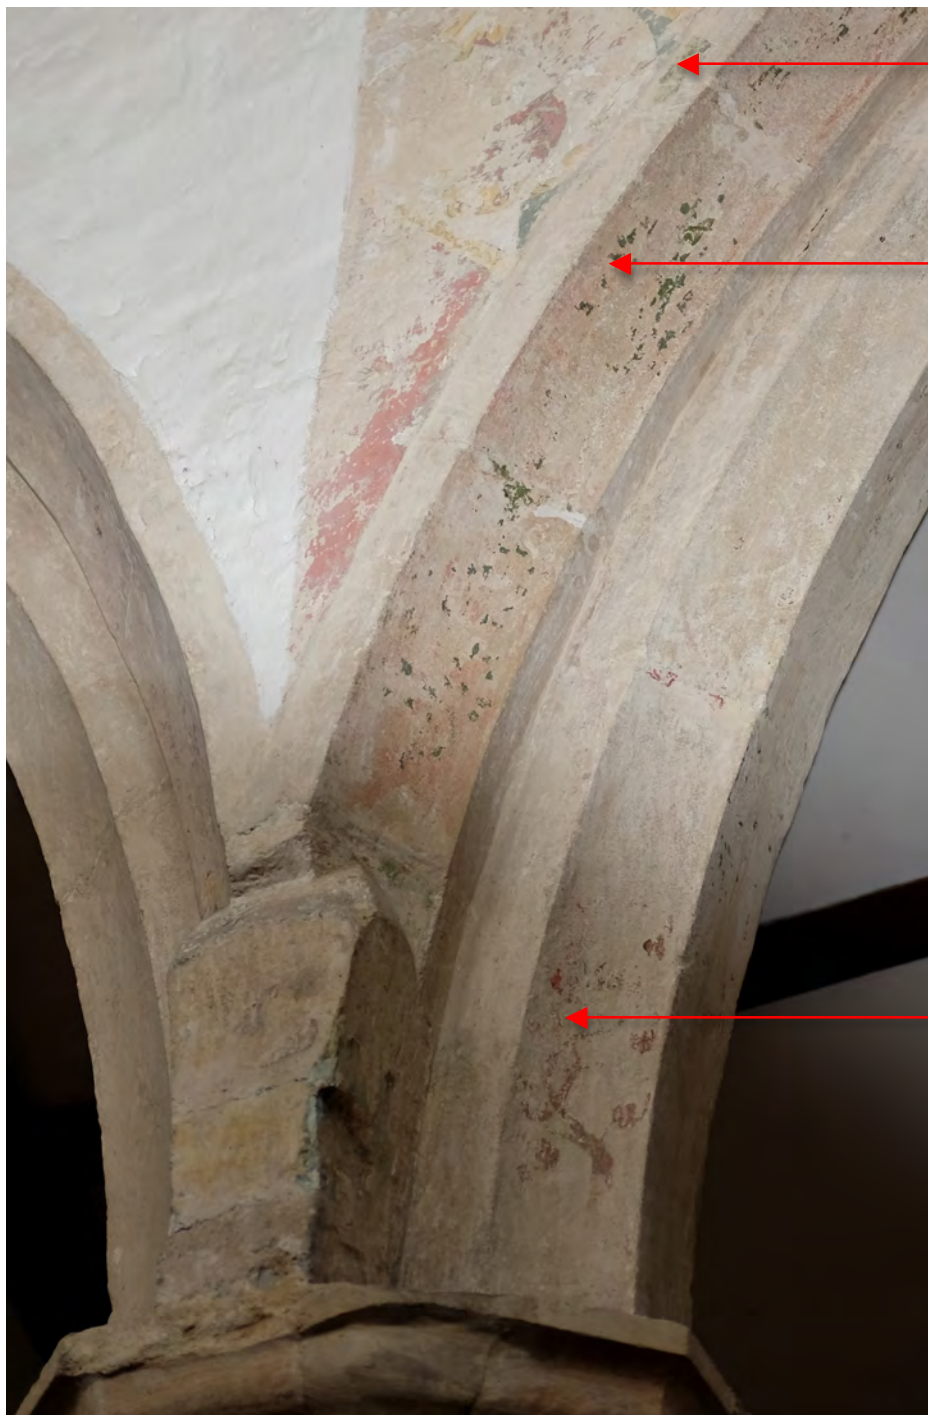
**Fig.4: Further traces of paint**

Further paint in close proximity to the wall paintings is visible on the archivolt of the arcade arch. The outline of the lozenge shape and traces of the black background extend onto the edge of the arch itself, with further red and black/green pigment visible. Furthermore, a twisted foliate design, similar to climbing ivy is visible on both sides of the arch, just above the capitals that presumably once extended entirely across the archivolt (see fig.4).

Yellow border and black background extend onto the edge of the arch

Black/green paint extending onto the archivolt of the arch

Twisted foliate design

If this paint is coeval with the wall paintings it is associated with them and adds further weight to the argument that the wall paintings may extend further.

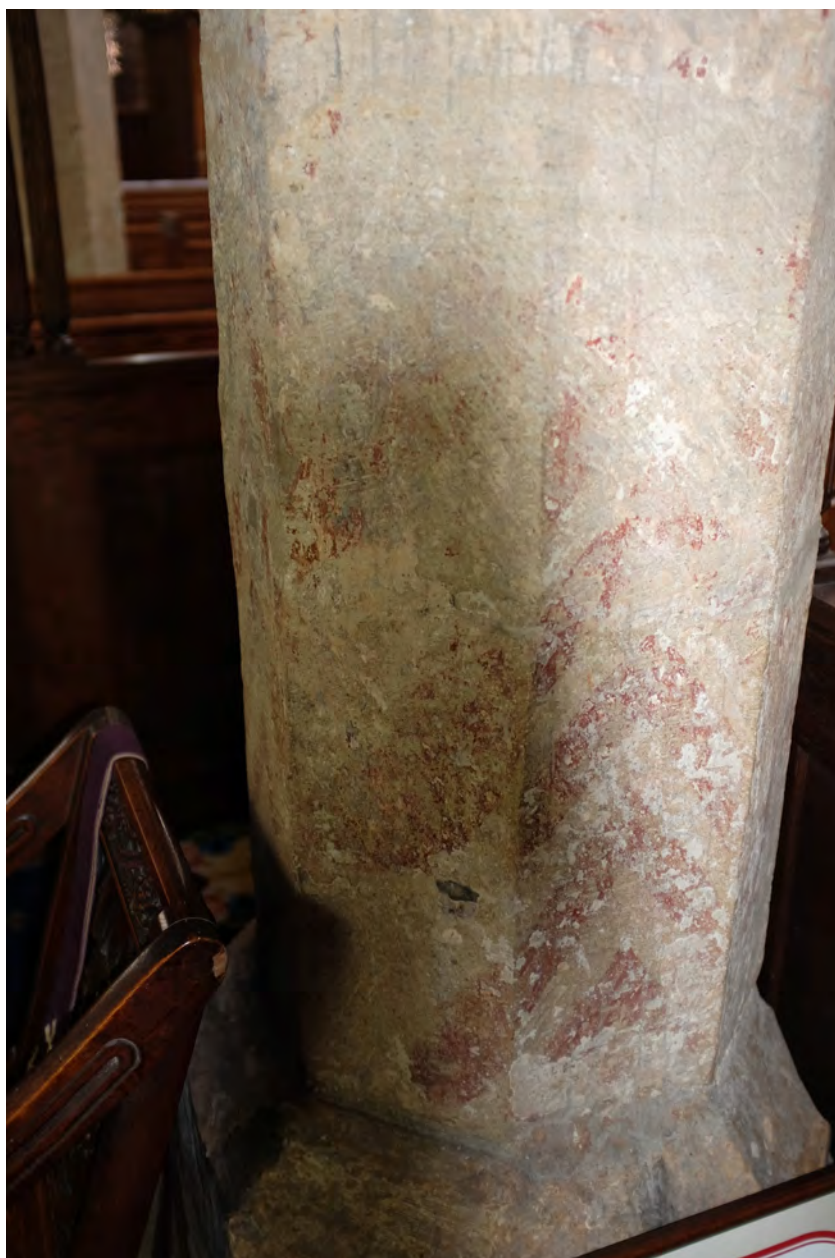
**Fig.6: 'Chevron' red paint in the nave**

The red detected on the arcade column is ubiquitous throughout the nave and manifested in some areas as a chevron design (fig.6).

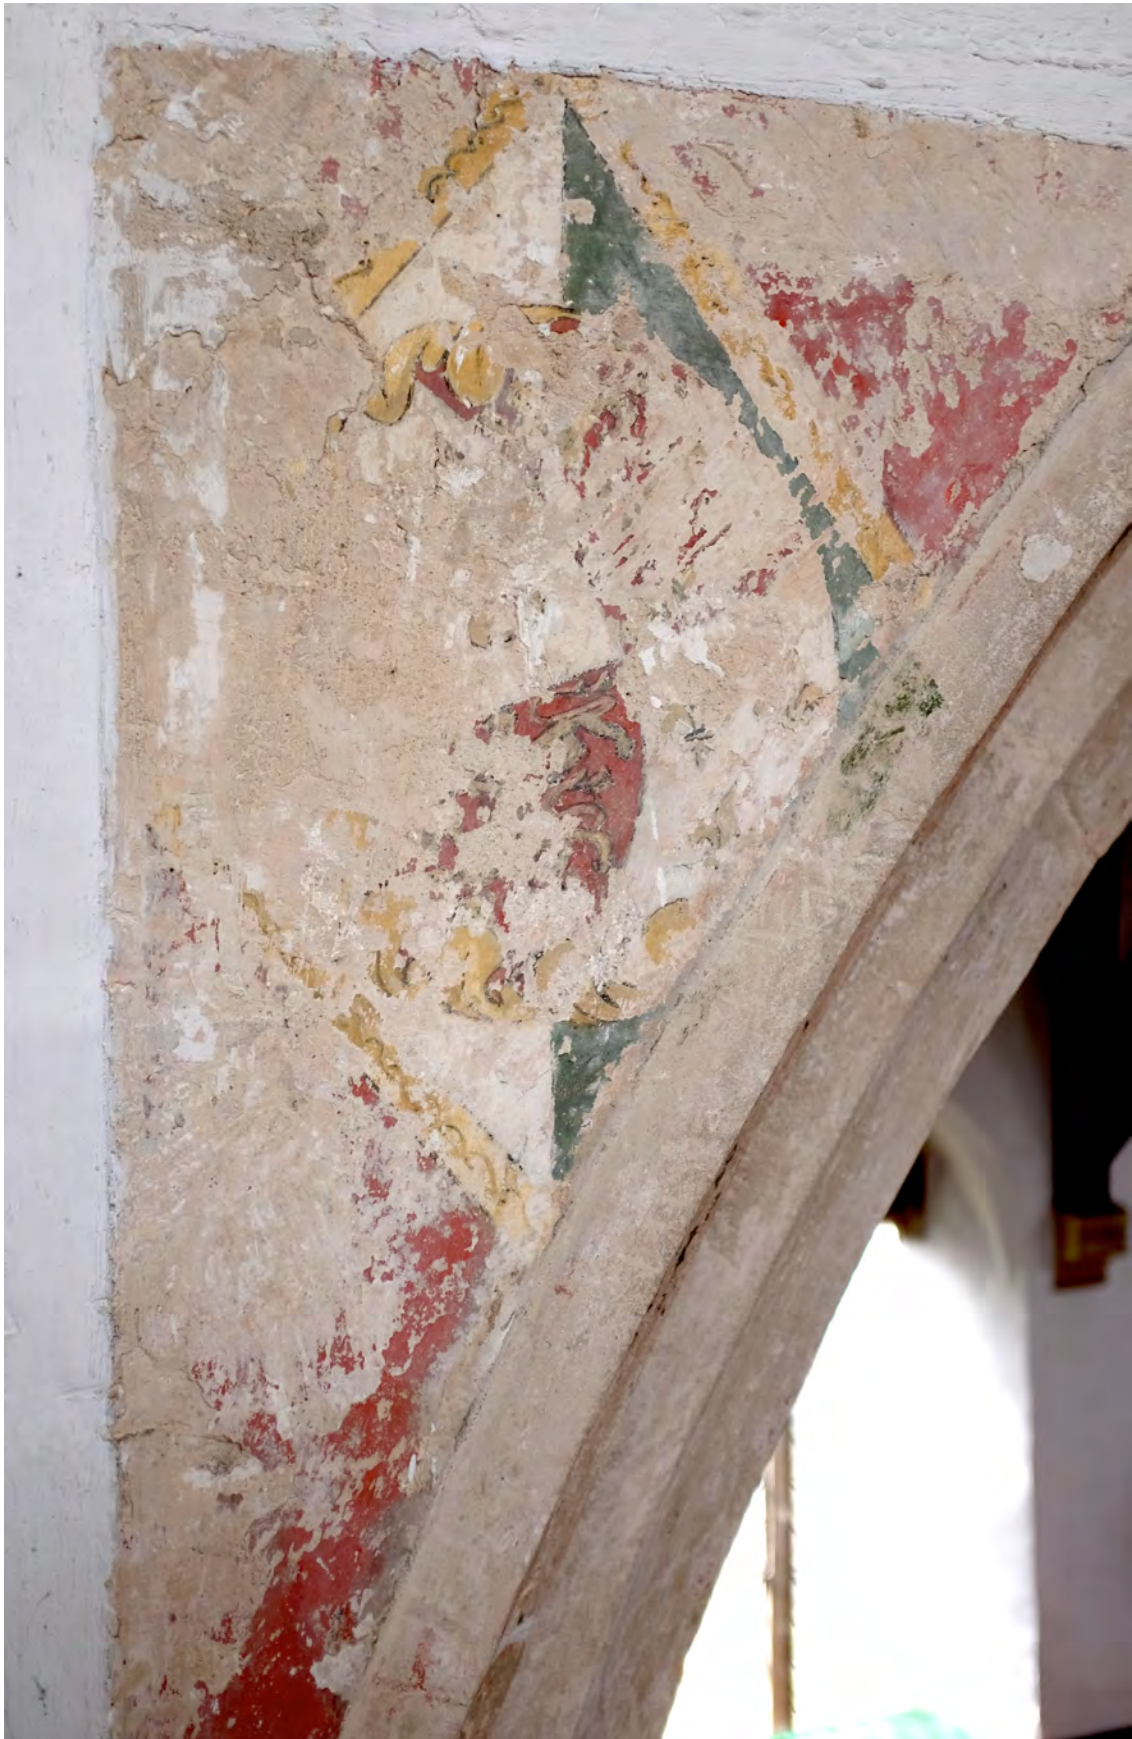
**Wall painting (left)**

A preliminary assessment of the wall paintings has highlighted their poor condition. A close inspection revealed several areas of loose painted surface plaster at immediate risk of detachment. The paint itself has a powdery texture and is de-naturing (i.e the binding medium that carries the pigment is deteriorating) leaving behind loose pigment and extenders.

- Undoubtedly the wall paintings are at immediate risk. The lime plaster substrate is lifting in some areas and in danger of imminent detachment. Immediate remedial intervention by an accredited conservator is required to stabilize both paintings and consolidate and hold back areas of loose and flaking plaster.
